Chapter-4

Coastal urbanization and associated risk

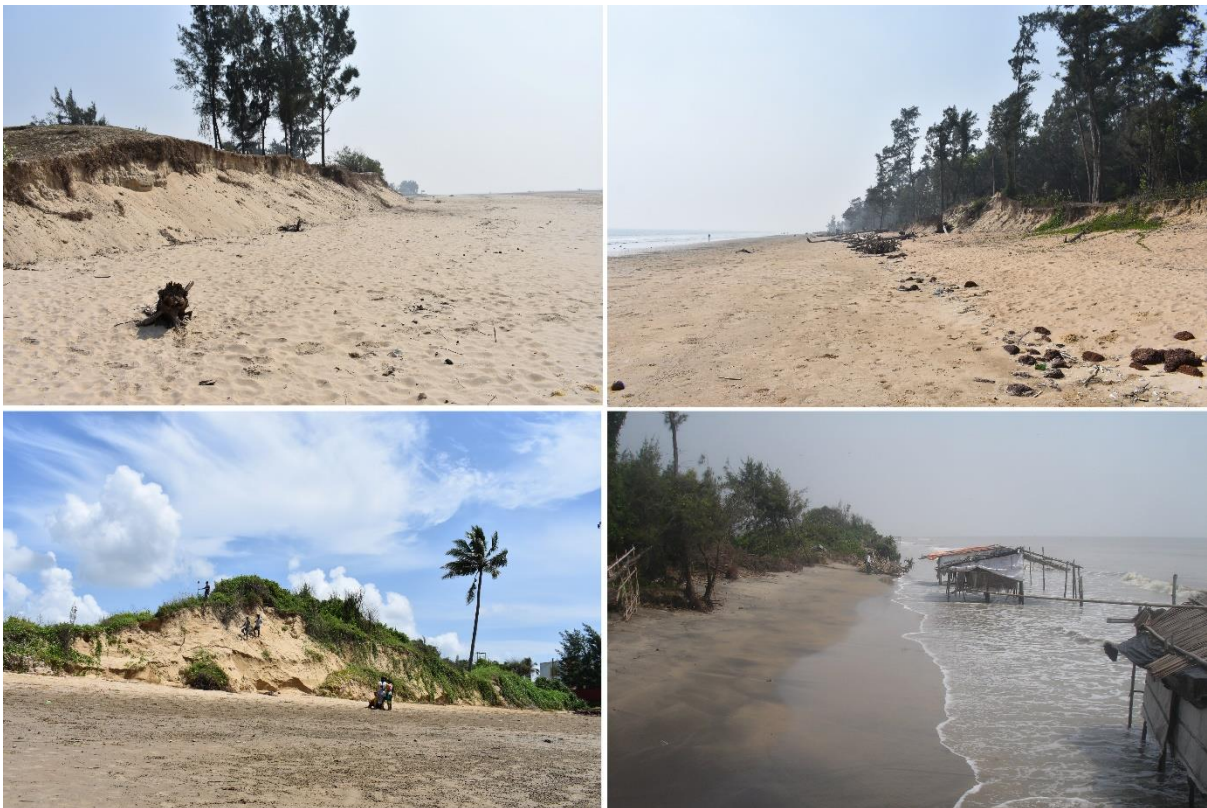
Plate 4.2: Shorefront sand dunes are severely eroded at the different sites of Mandarmani-Sankarpur coastal stretch.

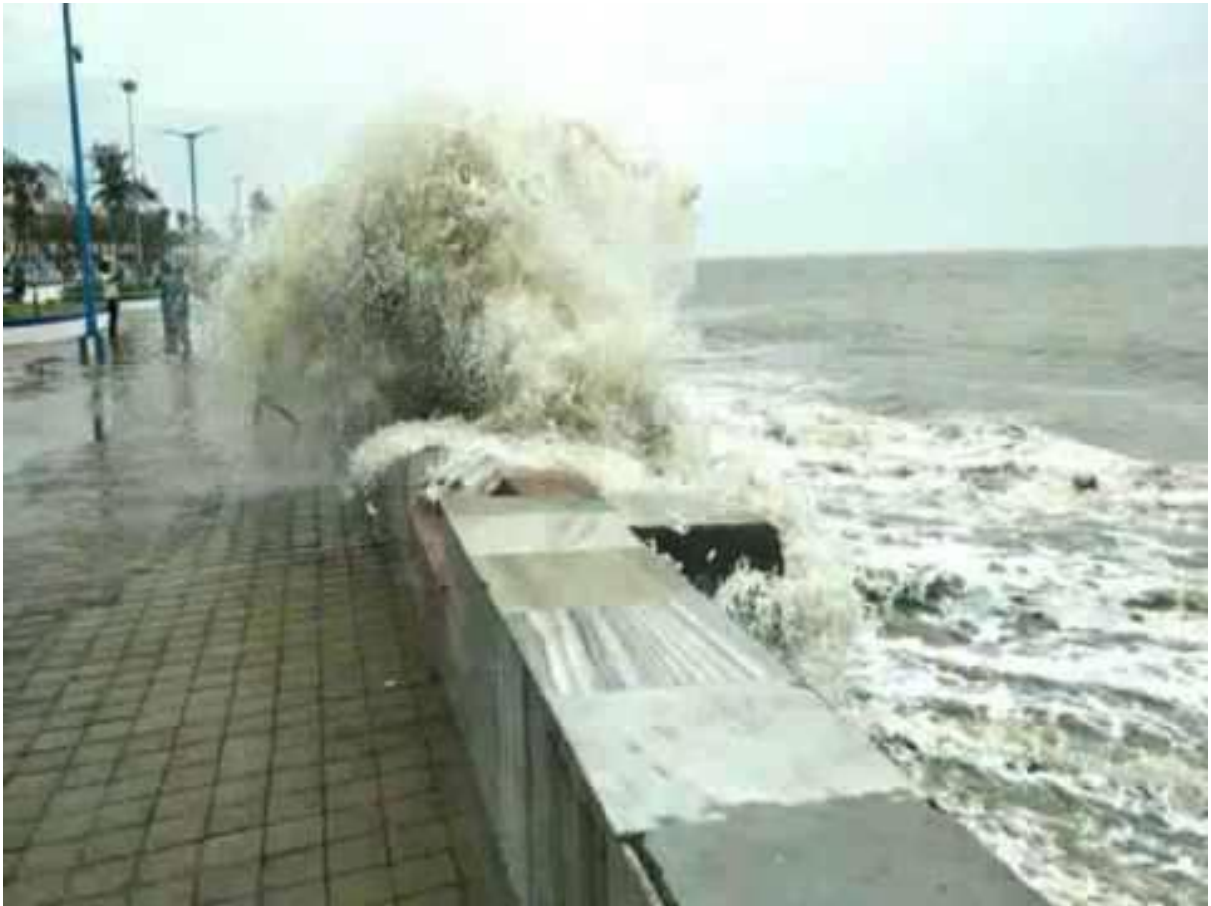
Plate 4.3: Cyclonic storm-wave overtopping the seawall at Digha.

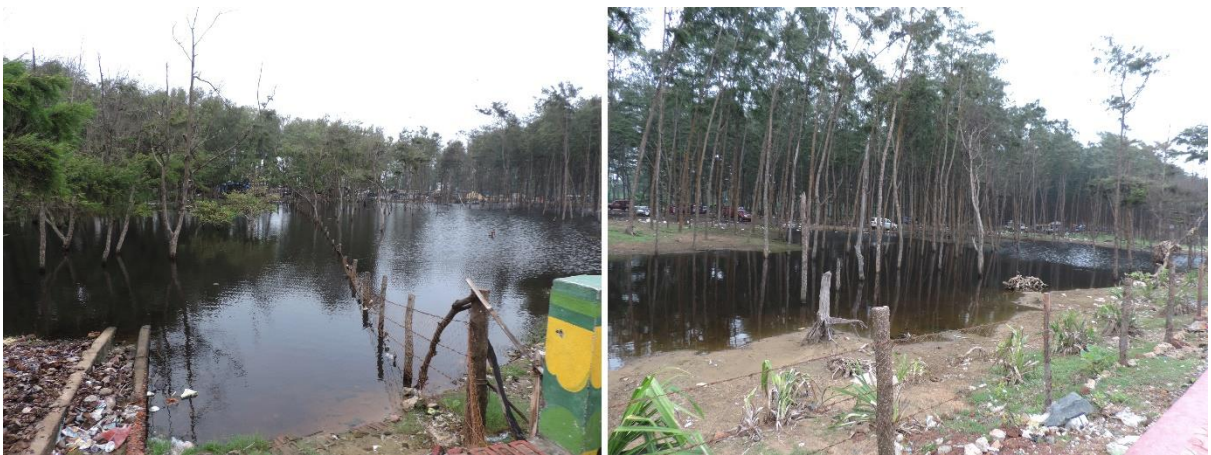
Plate 4.4: Cyclonic storm frequently inundating the new areas of shorefront position at Digha.

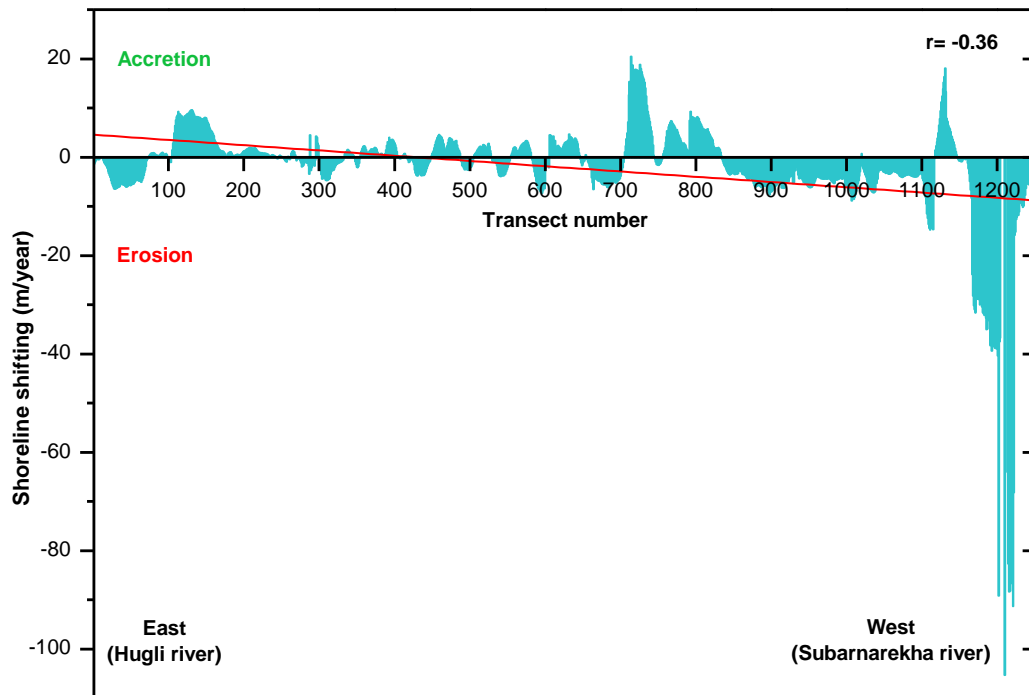
Fig. 4.18: Transect wise shoreline shifting rate and resultant erosion-accretion in and around the study area of Medinipur littoral tract during 1973 – 2018.

shoreline shifting within the coastal stretch of the Hugli river (north) to Subarnarekha river mouth (South) reveals the erosion trend (-0.36) (Fig. 4.18).

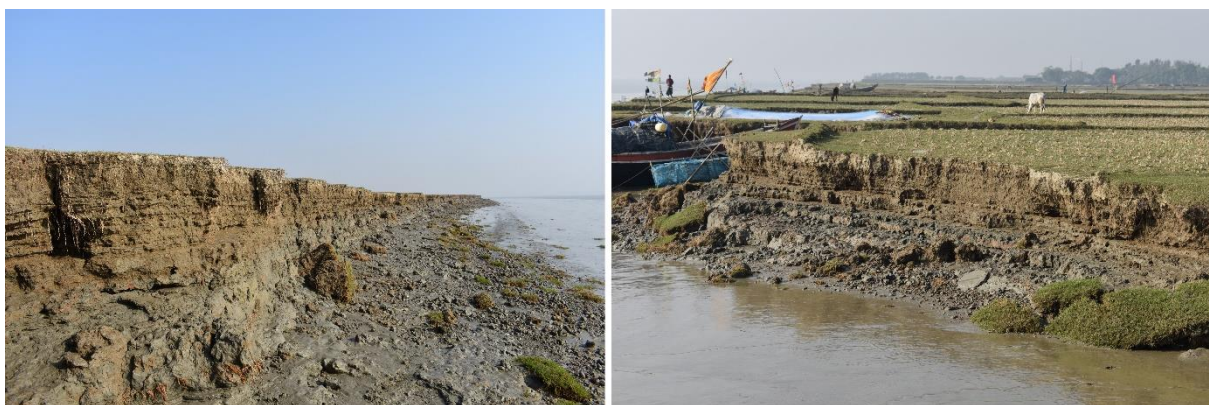
Plate 4.5: Mud-bank erosion at the right bank of Hugli river in Haldia.
